# Gutter, Cladding and Roof Light Condition Survey

Main building

| Report reference | ABS-XXX-000 (sample) |

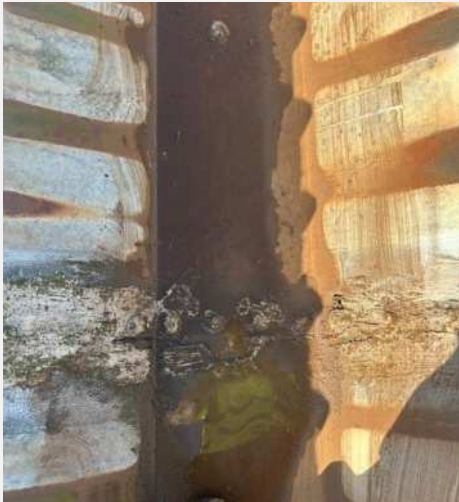
| Location | Main building - valley gutter joints | Visit | Condition survey |
|---|---|---|---|
| <p>VALLEY GUTTER JOINT - PREVIOUS PATCH REPAIR FAILING;<br/>CORRODED JOINT BOLTS; STANDING WATER AND ALGAE AT<br/>THE JOINT</p> | | <p>VALLEY GUTTER JOINT - FAILED PATCH REPAIR; RUST TO THE<br/>GUTTER SOLE; STANDING WATER AT THE JOINT</p> | |

| <b>Condition / defects</b> | The valley gutter joints have been patch repaired in the past, and these repairs are now failing. The sealant is cracked and breaking away, the joint bolts are corroded, and water is ponding at the joints with algae growth and rust to the gutter sole. Without prompt attention there is a high risk of significant leaks into the building. |

| <b>Recommendation</b> | Urgent attention is required before major leaks occur. Option 1: take out and reseal the gutter joints with two coats of liquid GRP. Option 2: install a Fatra single-ply membrane lining. |

| Item | Recommended Works | Priority | Cost (exclusive of VAT) |
|---|---|---|---|
| <b>4. Valley gutter joints (Option 1)</b> | Take out and reseal the gutter joints with two coats of liquid GRP (5 year warranty), and fit leaf guards to the outlets. | Urgent | £0000 |
| <b>6. Valley gutter lining (Option 2)</b> | Fatra single-ply membrane lining (25 year warranty), including new outlets with leaf guards, as an alternative to item 4. | Urgent | £0000 (alternative) |

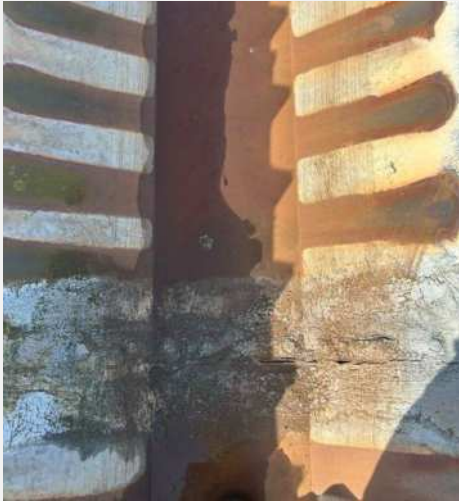
| Location | Main building - valley gutter joints | Visit | Condition survey |
|---|---|---|---|
| <p>VALLEY GUTTER JOINT - PREVIOUS SEALANT REPAIR FAILING<br/>AND CRACKED; RUST TO THE GUTTER SOLE</p> | | <p>VALLEY GUTTER JOINT - FAILED PATCH REPAIR WITH<br/>SEALANT BREAKING AWAY; SILT AND STANDING WATER</p> | |

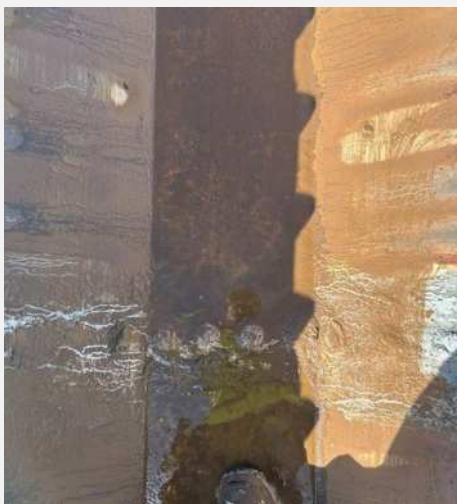
VALLEY GUTTER JOINT - CORRODED JOINT BOLTS; FAILED SEAL; ALGAE AND STANDING WATER AT THE JOINT

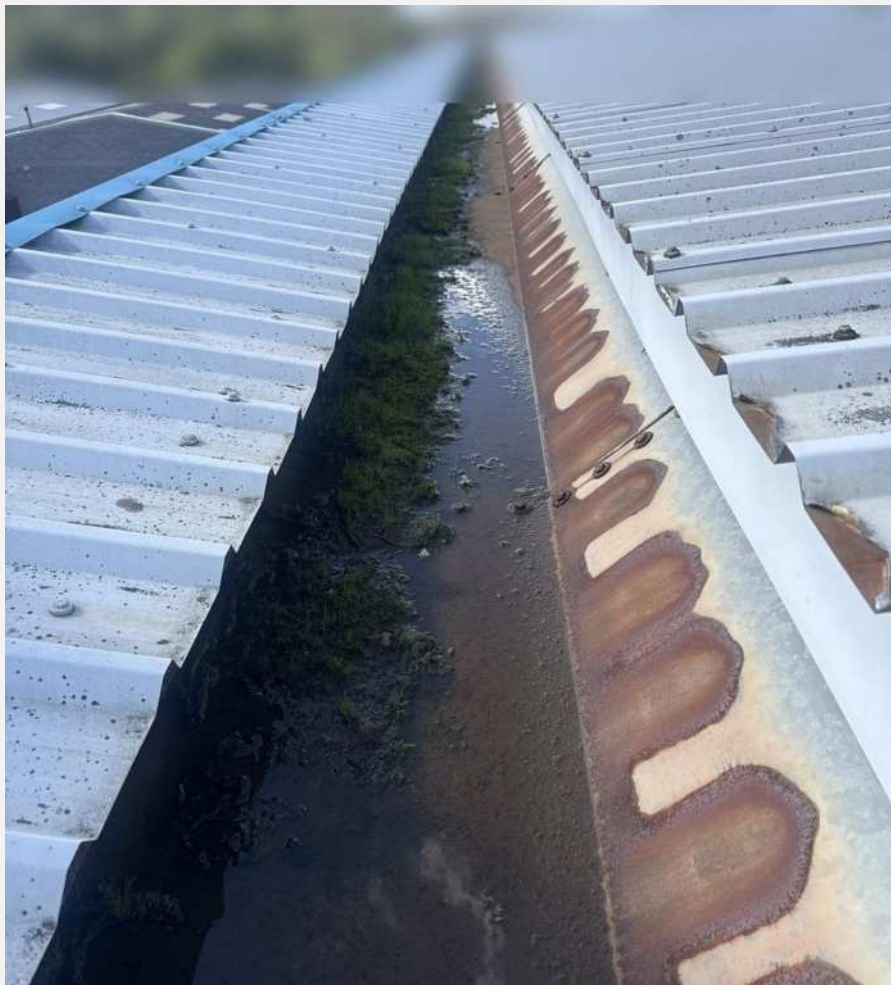
EXTERNAL PERIMETER GUTTER RUN - SILT, GRASS AND STANDING WATER IN THE GUTTER SOLE; HEAVY RUST STAINING ALONG THE SIDEWALL

| <b>Condition / defects</b> | The external perimeter gutter is formed in galvanised steel and shows significant corrosion, with heavy rust staining along the sidewall. Silt, grass and moss have built up in the gutter sole, with standing water along the run. The gutter is currently suitable for lining. |

| <b>Recommendation</b> | Clean out as soon as possible to prevent blocked outlets and drainage. Option 1: take out and reseal the gutter joints with two coats of liquid GRP. Option 2: install a Fatra single-ply membrane lining. |

| Item | Recommended Works | Priority | Cost (exclusive of VAT) |
|---|---|---|---|
| <b>2. Gutter clean - external perimeter gutters</b> | Clean out the external perimeter gutters and outlets as soon as possible, to prevent blocked outlets and drainage. Client to provide general waste bins for the gutter debris. | Urgent | £0000 |
| <b>5. External perimeter gutter joints (Option 1)</b> | Take out and reseal the gutter joints with two coats of liquid GRP (5 year warranty), and fit leaf guards to the outlets. | Urgent | £0000 |
| <b>7. External perimeter gutter lining (Option 2)</b> | Fatra single-ply membrane lining (25 year warranty), including new outlets with leaf guards, as an alternative to item 5. | Urgent | £0000 (alternative) |

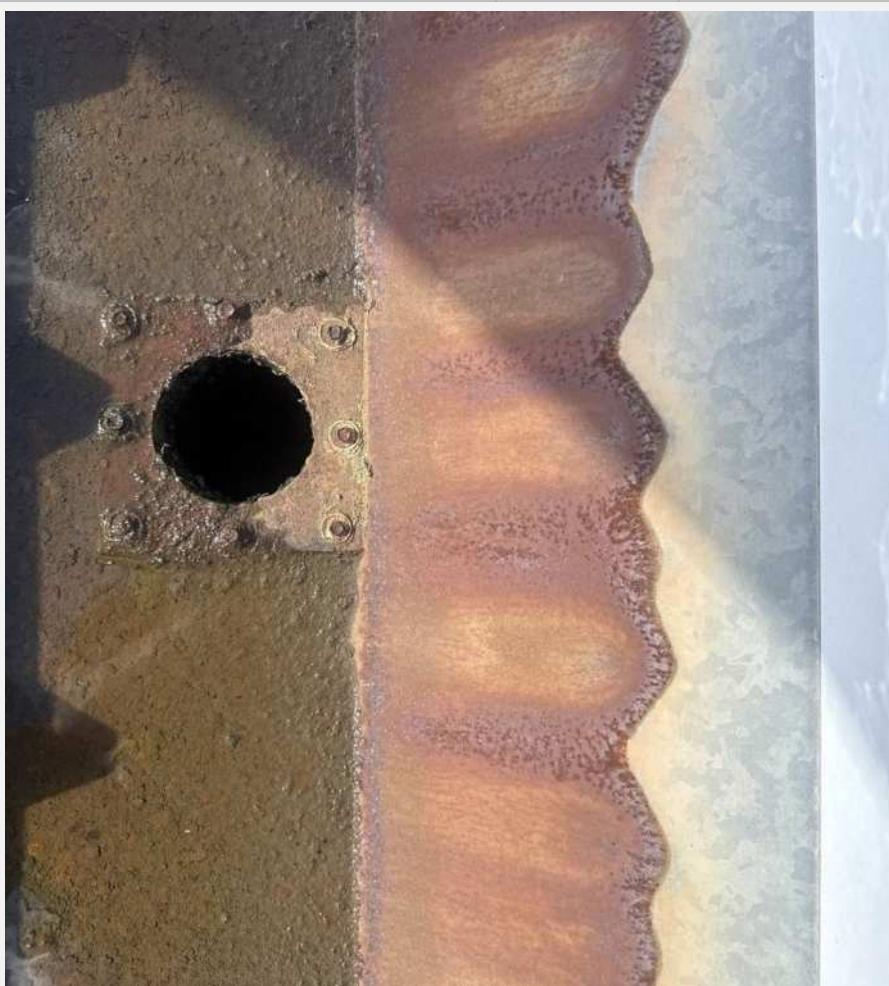
EXTERNAL PERIMETER GUTTER OUTLET - NO LEAF GUARD; CORRODED FLANGE BOLTS; RUST AND SILT TO THE GUTTER SOLE AND HEAVY RUST STAINING TO THE SIDEWALL

| <b>Condition / defects</b> | No leaf guard is fitted to the outlet, and the outlet flange bolts are corroded. The gutter sole is rusted and silted, and the sidewall shows heavy rust staining where water has sat against it. |

| <b>Recommendation</b> | Option 1: fit leaf guards to the outlets; Option 2: new outlets with leaf guards. Replace the corroded outlet fixings and detail the outlets within the gutter joint or lining works. |

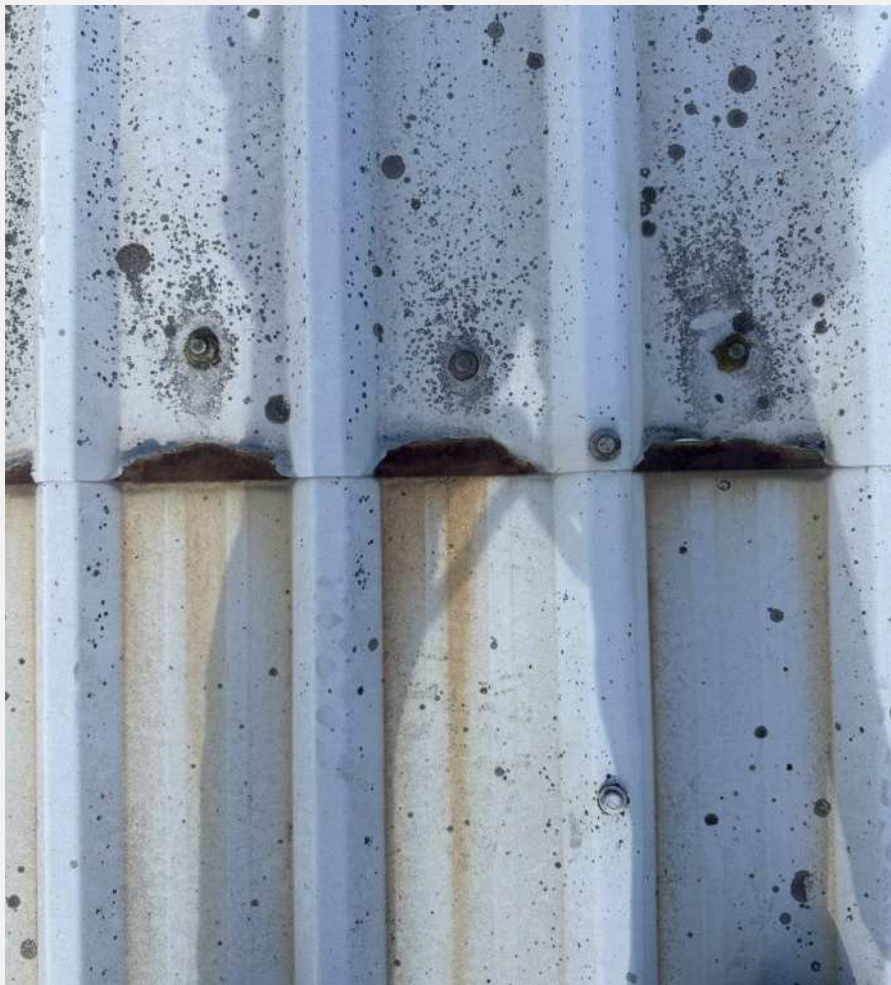
*SHEET END LAP - COATING DELAMINATION AND CUT-EDGE CORROSION ALONG THE LAP; LICHEN AND DIRT ON THE SHEETS;  
RUST STAINING BELOW THE LAP*

| <b>Condition / defects</b> | The sheet end laps show coating delamination with cut-edge corrosion along the lap, and rust staining running down the sheet below. Lichen and dirt are present across the sheets. |

| <b>Recommendation</b> | Cut back and treat where sufficient end lap remains; otherwise clean back, apply a rust inhibitor and two coats of liquid GRP. |

| Item | Recommended Works | Priority | Cost (exclusive of VAT) |
|---|---|---|---|
| <b>3. Sheet end laps</b> | Cut back and treat where sufficient end lap remains; otherwise clean back, apply a rust inhibitor and two coats of liquid GRP. | Planned repair - soon | £0000 |

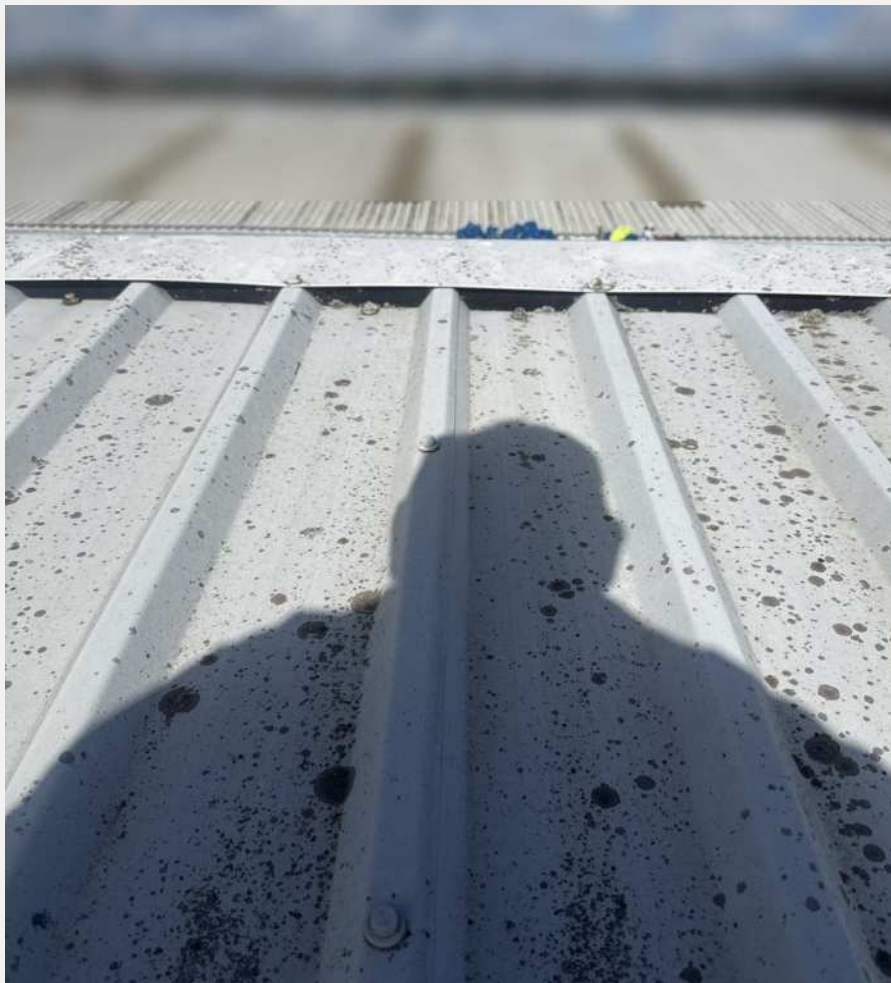
ROOF SLOPE - HEAVY DIRT, LICHEN AND MOSS; WEATHERED FIXINGS; ROOF LIGHTS ON THE ADJACENT ROOF DIRTY AND DISCOLOURED

| <b>Condition / defects</b> | Heavy dirt, lichen and moss across the roof sheeting, with a weathered coating and fixings. The roof lights are dirty and discoloured, reducing daylight to the building. |

| <b>Recommendation</b> | No works required at present; observe the roof sheeting and roof lights at each planned gutter maintenance (PPM) visit. |

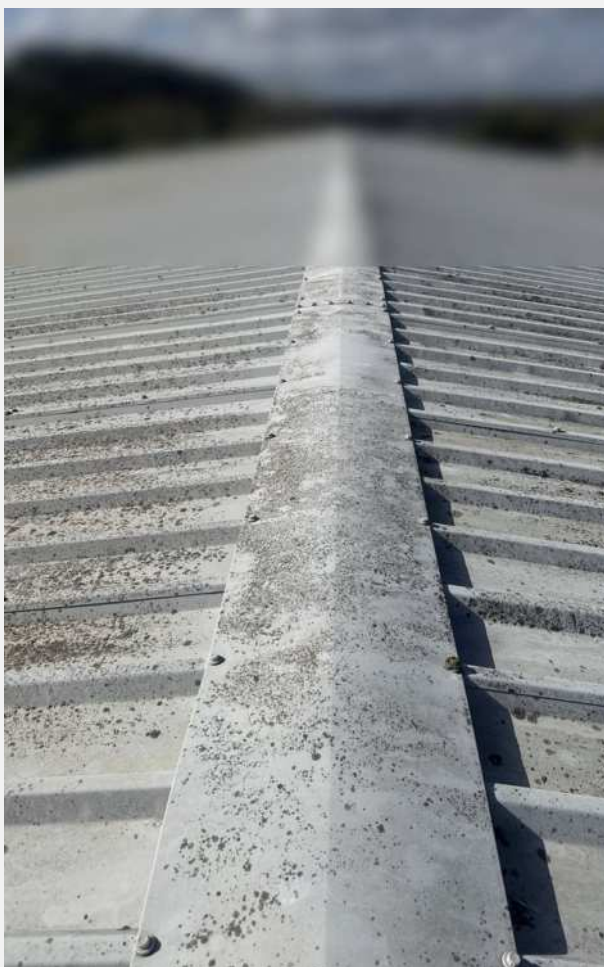
RIDGE CAPPING ALONG THE ROOF - CONTINUOUS AND FIXED; DIRT, LICHEN AND MOSS ON THE CAPPING

| <b>Condition / defects</b> | The ridge capping is in satisfactory condition, with the capping and joints fixed. Dirt, lichen and moss are present on the capping. |

| <b>Recommendation</b> | No repair required at present; monitor the ridge at each planned gutter maintenance visit. |

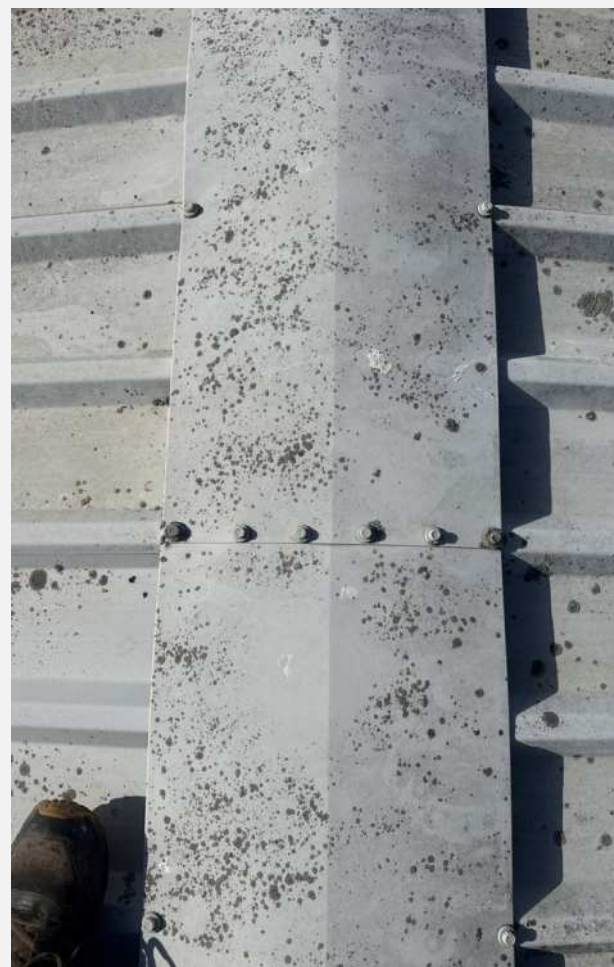
RIDGE CAPPING JOINT - FIXINGS IN PLACE; DIRT, LICHEN AND MOSS ON THE CAPPING
